1993 NORTHEASTERN MT COAL MAINTENANCE PROJECT

DSL - AMRB No. 93-M03

FINAL REPORT

SPECTRUM ENGINEERING

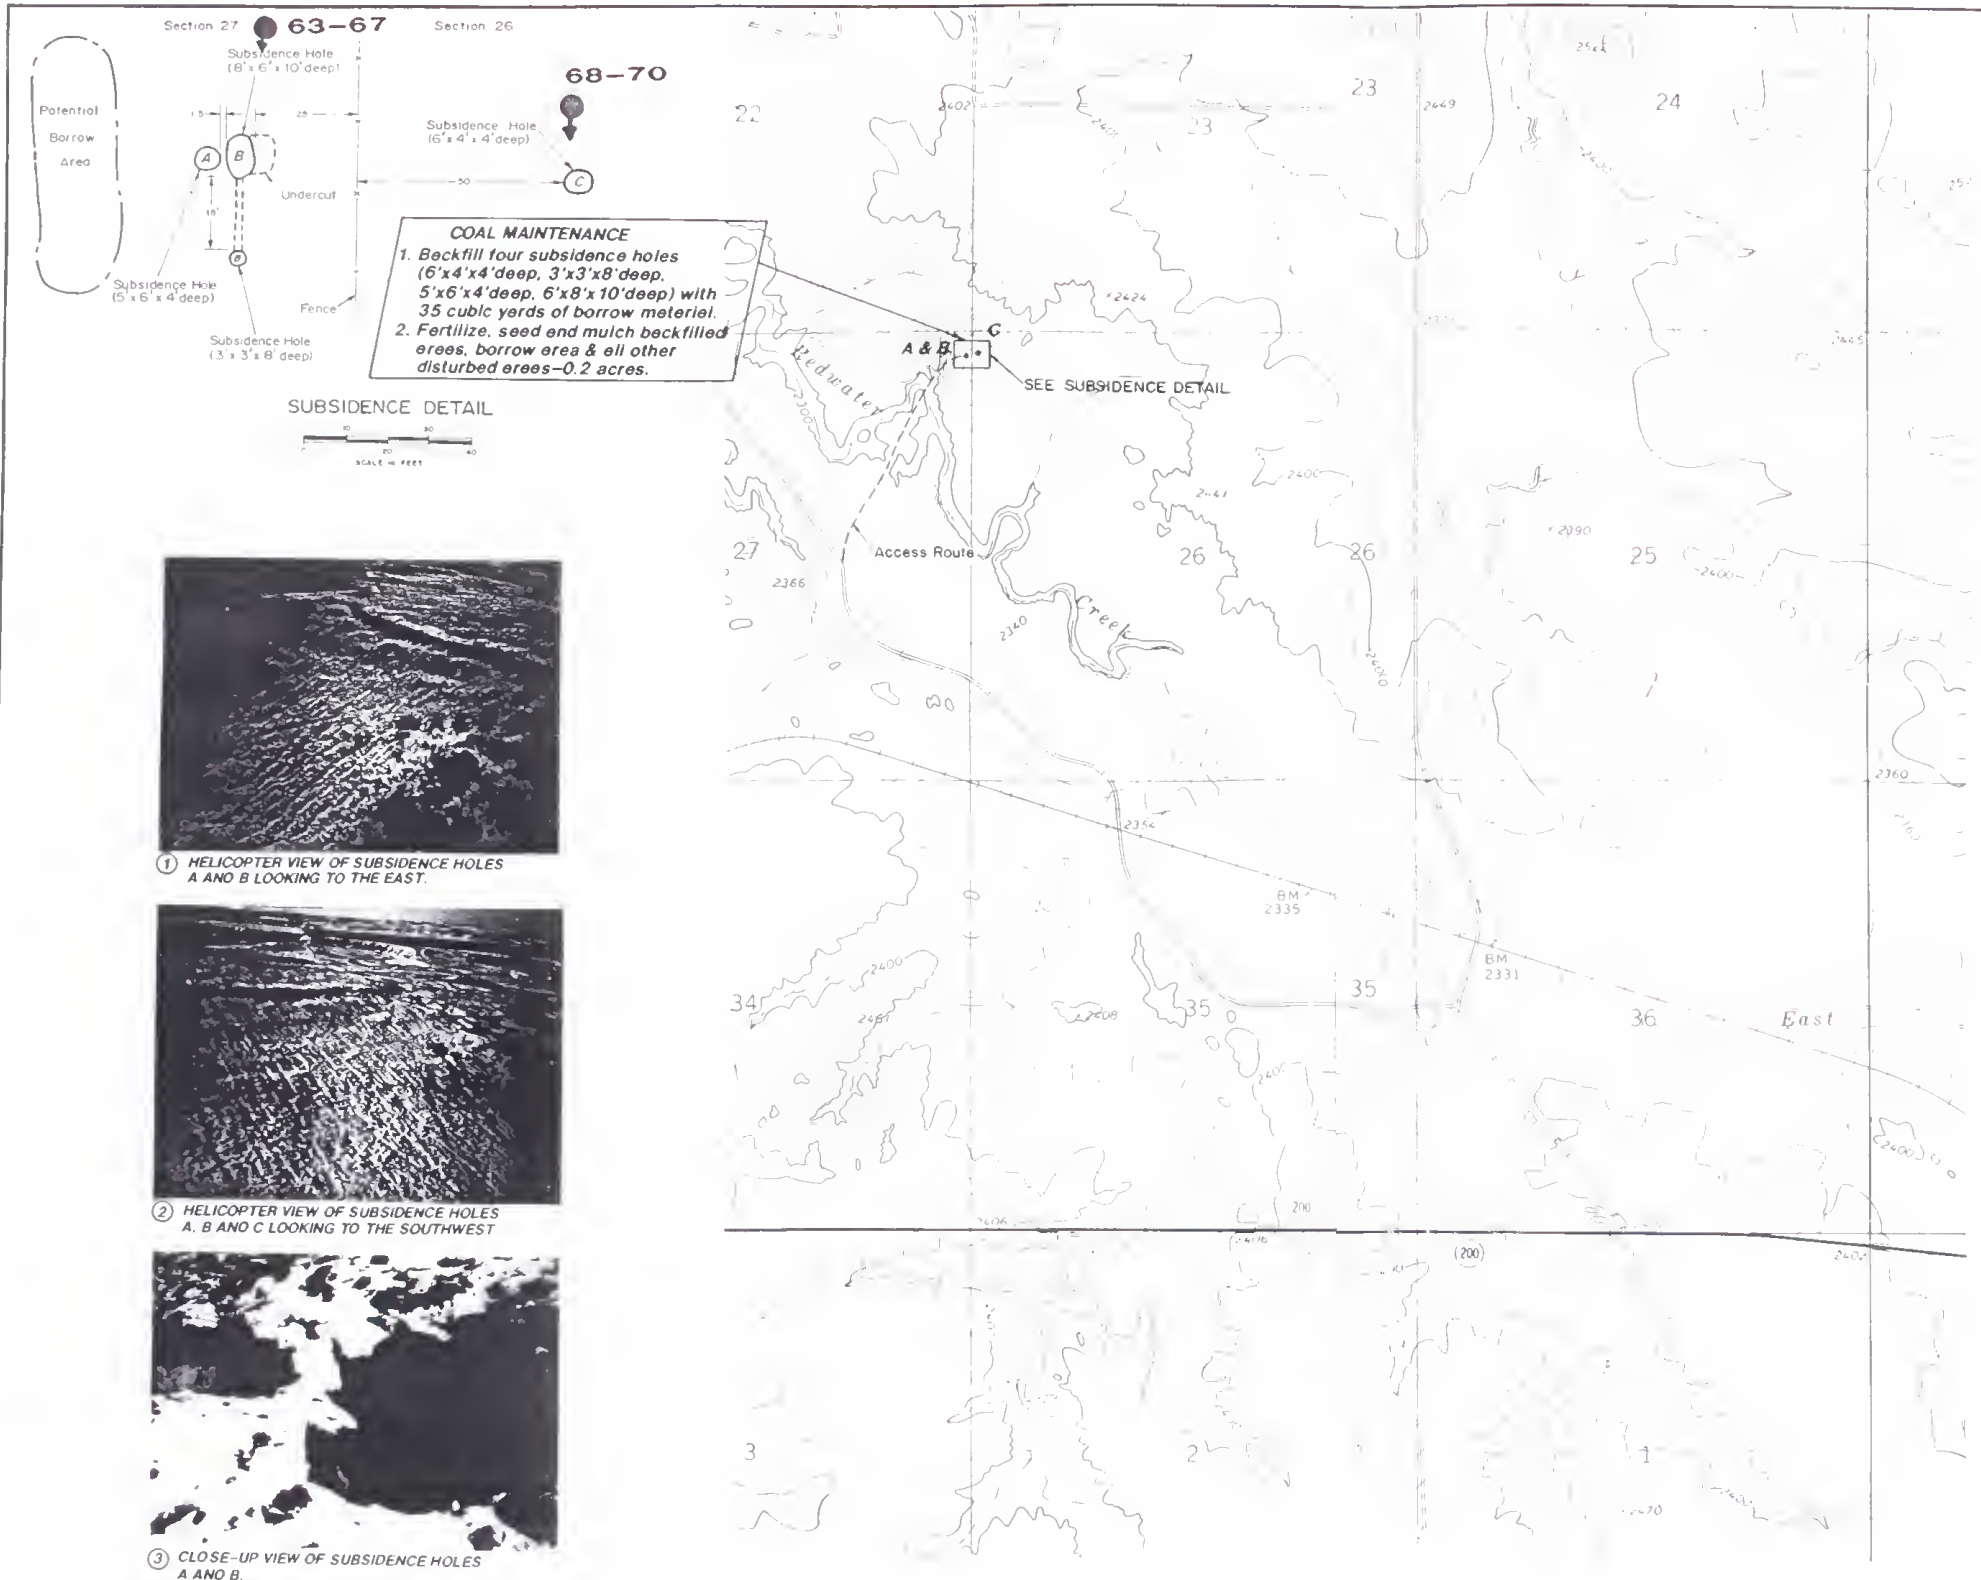
1 HELICOPTER VIEW OF SUBSIDENCE HOLES A AND B LOOKING TO THE EAST.

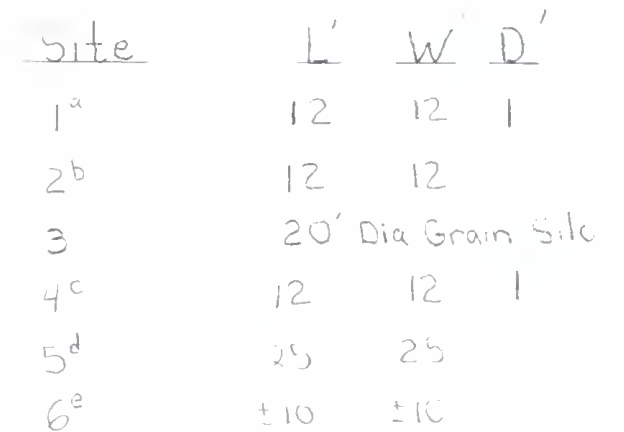
- a. Small concrete blocks present, supposedly site of main shaft
- b. Barren circular patch in grassy field. Owner said this hole has been filled.
- c. Slightly depressed area that owner has filled. Supposedly site of main shaft.
- d. Coal slacked area supposedly a shaft area, presently filled in.
- e. Owner claims a sinkhole use to exist here, presently filled in.
- f. Area is heavily overgrown in brush. Owner claims some sinkholes exist in this area, although none were found. Also, next door neighbor's (shown) sewer drain line in this area.

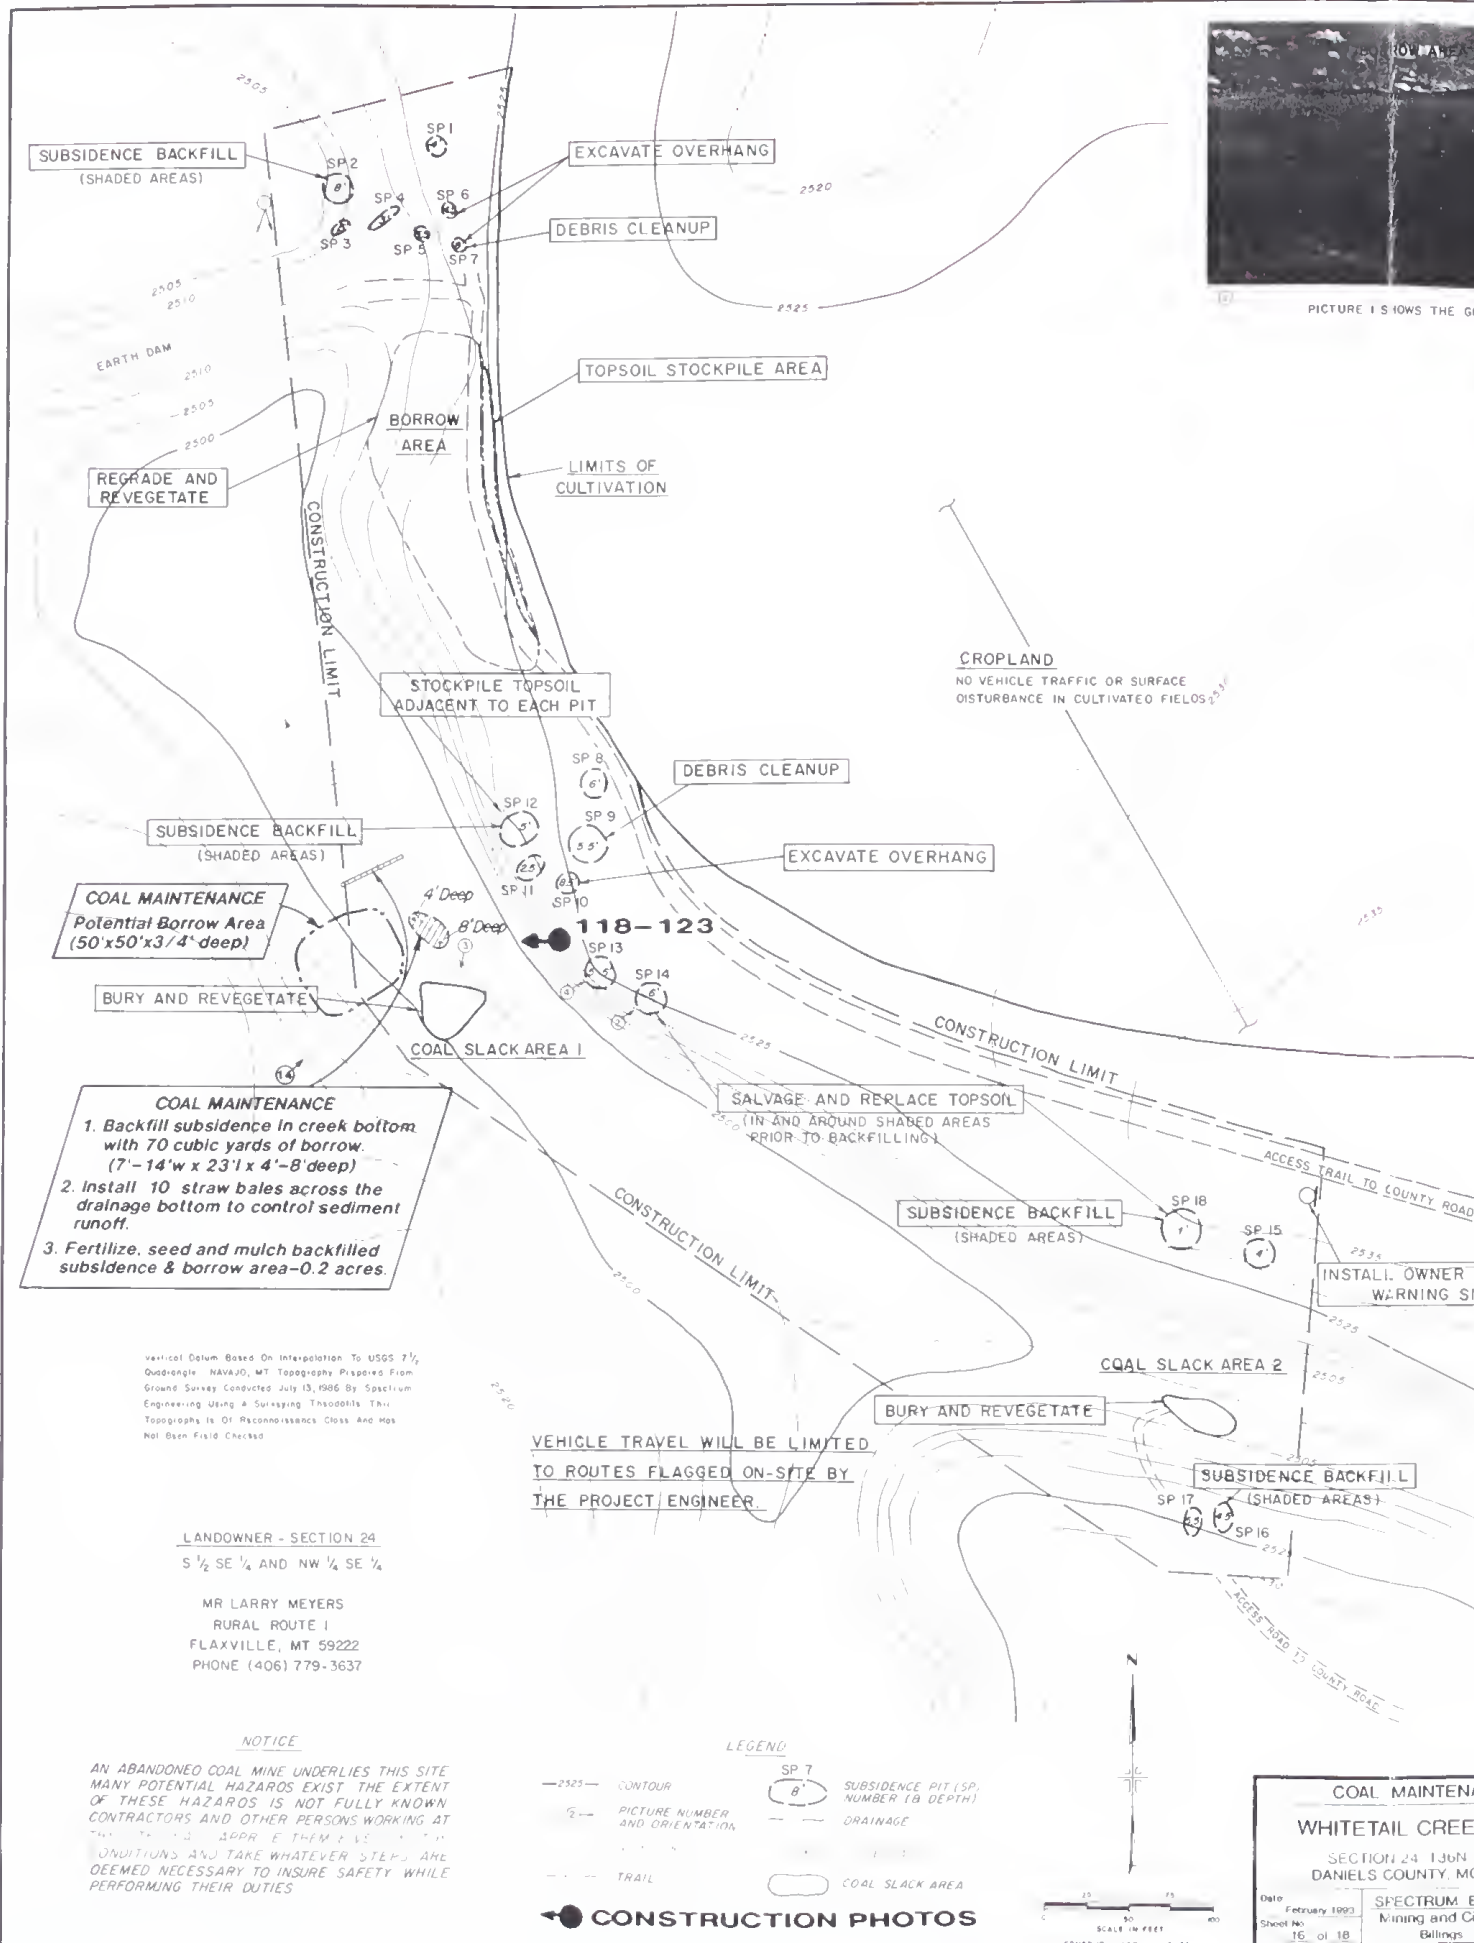
PICTURE 1 SHOWS THE GENERAL PROJECT AREA AND THE BORROW AREA
